**Technical Bulletin No. T25.2FL**

**\*\*\* Important Technical Notice for Fire-Lite Dealers and Distributors \*\*\***

**Models Affected: ES-1000X**

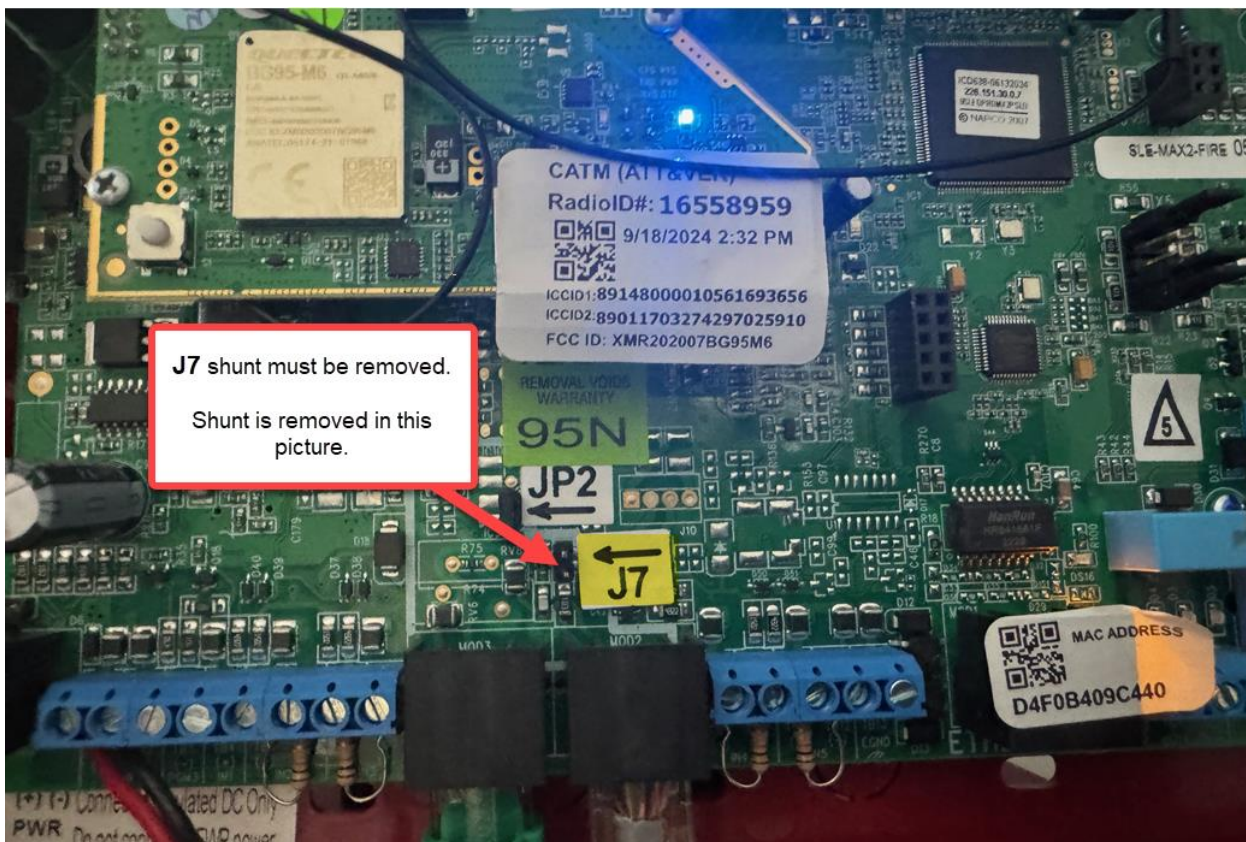
2) Shunt "J7" must be removed from the StarLink radio board.

The root cause of this issue is due to a jumper/shunt setting on the StarLink radio board. This shunt, when left installed, places a 10k resistor across pins 1 and 8 of the POTS port. This resistor is used by StarLink's optional TELCO LINE supervision and interferes with our communicator's (CCP) supervision of the phone line, resulting in a TELCO LINE fault at our panel.

- a) Remove power from the StarLink radio (for safety reasons and to avoid a "Tamper" event).
- b) Remove the two screws holding the cover on the radio and remove the cover.
- c) Locate the shunt labelled "J7" and pull up on it to remove it. You should now see 2 pins sticking out of the board.
- d) Replace the cover and the two screws.
- e) Apply power to the StarLink radio.
