Summary of issue: Effective Monday, March 3, 2008, all new System Sensor outdoor horns, strobes, and horn/strobes will ship with mounting plates with the shorting spring in the open position

Model numbers: The affected models are all “K” series outdoor horns, strobes and horn/strobes: HRK, P2RK, P2RHK, PC2RK, PC2RHK, SRK, SCRK, SRHK, SCRHK, P4RK, P4RHK, PC4RK, PC4RHK and all replacement models HRK-R, P2RK-R, P2RHK-R, PC2RK-R, PC2RHK-R, SRK-R, SCRK-R, SRHK-R, SCRHK-R, P4RK-R, P4RHK-R, PC4RK-R, PC4RHK-R

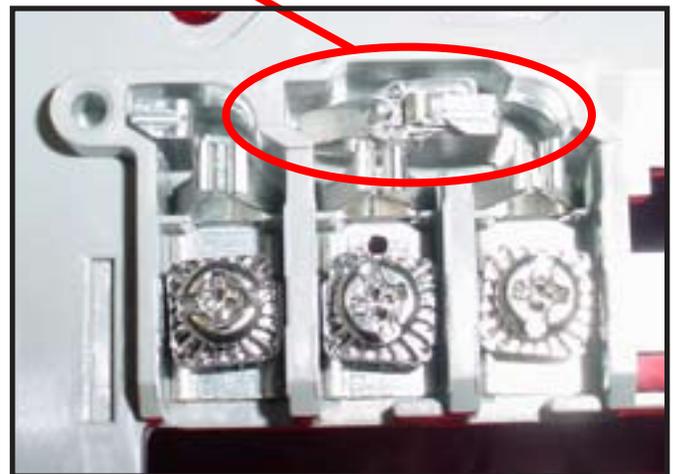
SHORTING SPRING

Issue: The SpectrAlert Advance mounting plate uses a shorting spring between the two positive terminals (see photo) to allow wiring continuity to be verified without the device installed. After installation, if the device is removed from the plate, the contact should be disengaged resulting in a trouble (or “open”) indication at the panel.

It has been determined that on outdoor units only the rubber gasket around the mounting plate may not allow the contact to be locked open when the device is attached. As a result, if the device is ever removed from the mounting plate, the panel may not detect a trouble signal. Installed product remains operational in all cases.

Corrective Action: System Sensor is working on a permanent solution to the condition. In the short term, the issue can be corrected by manually locking the contact into the “open” position. This can be done by using a small flat head screw driver and gently putting pressure on the dimpled area of the shorting spring. You can verify it is disengaged by ensuring the two metal pieces are not touching. Please make sure the shorting springs are disengaged as part of your regular maintenance schedule.
