## MAXPRO® NVR 4.5 “What’s New” Software Release Notes

These Release Notes cover the new features and enhancements in the latest MAXPRO NVR 4.5 Build 162 software releases and apply to all variants of MAXPRO NVR and NVR Hybrid.

**Document Last Updated:** August, 2017

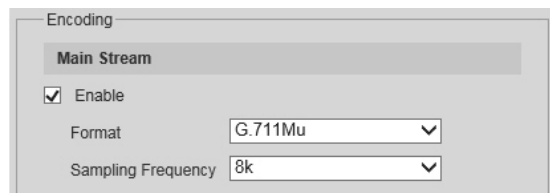
- For Venus camera models, Audio Quality is very poor in NVR for both live and playback operations.

**Workaround:** Change the camera Adapter configuration from default value (of ALaw and 48K) to **Format: MuLaw** and **Sampling Frequency: 8K** as shown below.
