NOTIFIER® by Honeywell

Technical Bulletin

Addressable Detector Insertion and Removal

TB13-11-01

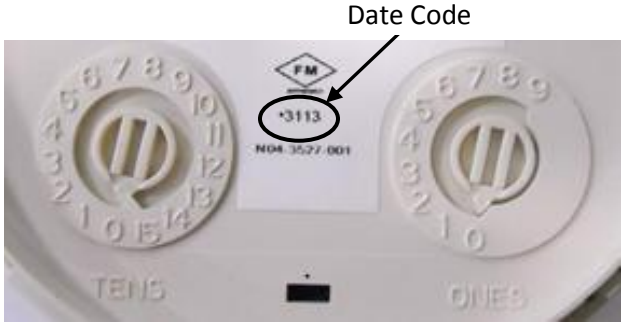
Figure 1

The manufactured date range of potentially affected detectors is June 3, 2013 (3061) through November 10, 2013 (3112). The date code label is located on the nameplate on the back of the detector. Date code 3061 defined as 3 = 2013, 06 = June, 1 = 1st week of the month. 3112 defined as 3 = 2013, 11 = November, 2 = 2nd week of the month. See Figures 1 and 2 below for locating the date code on the detector.
