Application firmware revision: 20.0

Models affected: All

Filename: S04-0138-007

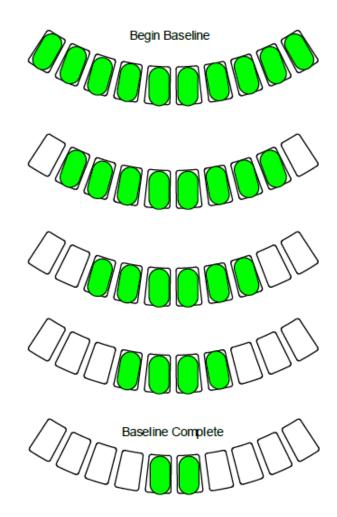
The user interface has been updated to indicate the amount of time remaining during airflow baselining.

If the system has not been baselined or a baseline reset has been initiated the device will illuminate all 10 segments on the airflow graph. As the baseline period progresses the segments will gradually turn off starting from the outside until it reaches the two center segments indicating the device has completed baselining. The baselining period is approximately 5 minutes.

If the device was previously baselined then the two center segments on the airflow graph will blink during the power on initialization period. The power on initialization period is approximately 5 minutes.

Press and hold the Reset button for 40 to 50 seconds to reset the airflow baseline. The airflow LEDs on the user interface will now indicate the amount of time remaining to re-baseline the airflow.
